ecology and environment, inc.

Re: O'Hara Property Municipal Landfill St. Charles, Illinois TDD# T05-9311-001 PAN# EIL0817SAA

ATTACHMENT B
PHOTODOCUMENTATION

SITE NAME: O'Hare Property Municipal Landfill PAGE 1 OF 6

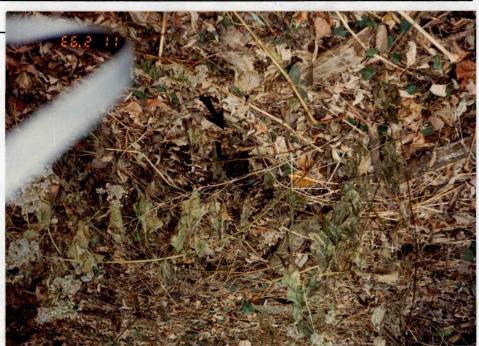
DESCRIPTION: View of burried drum partially surfacing from the ground.

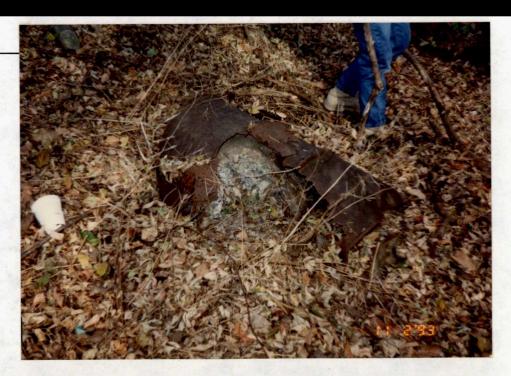
DESCRIPTION: View of a drum with contents that had solidified and exposed.

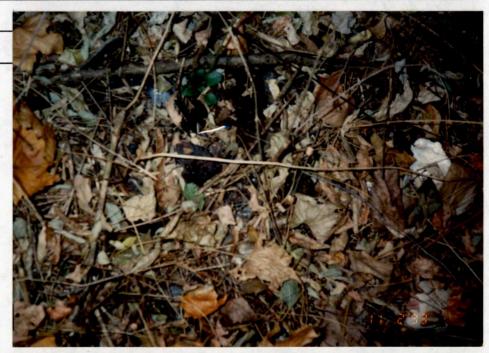
DESCRIPTION: By-products from furnace operations such as clinkers were evident such as what is shown in the picture.

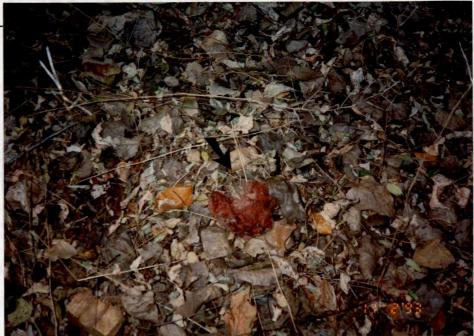
DESCRIPTION: More of clinkers that were seen on the

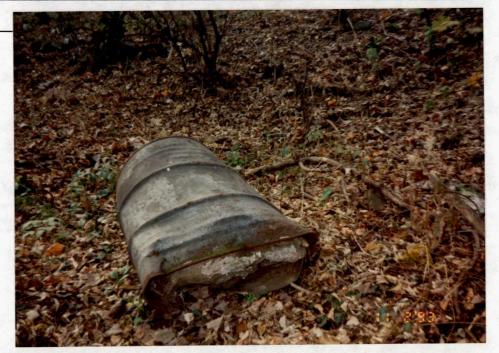
DESCRIPTION: View of another drum with contents that were solidified and exposed.

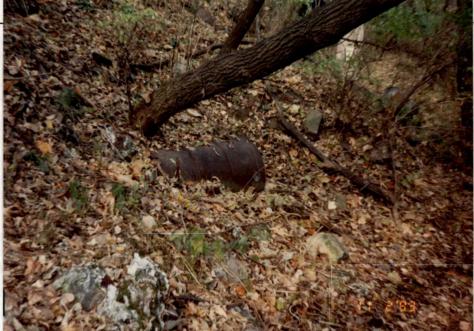
DESCRIPTION: View of more burried drums that lay partially exposed in the landfill.

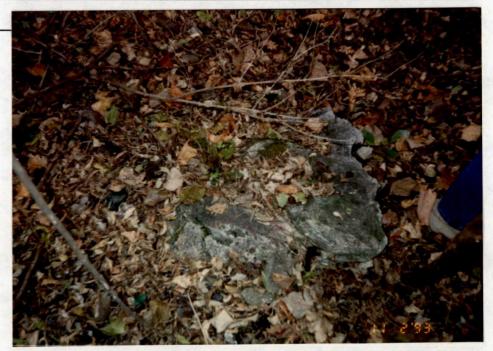
DESCRIPTION: Picture of what looked like slug also found on the landfill.
